Oliver Community League Hall Status Info Session

Presented by Oliver Community League
Hall Redevelopment Director, Blaine Kovacic

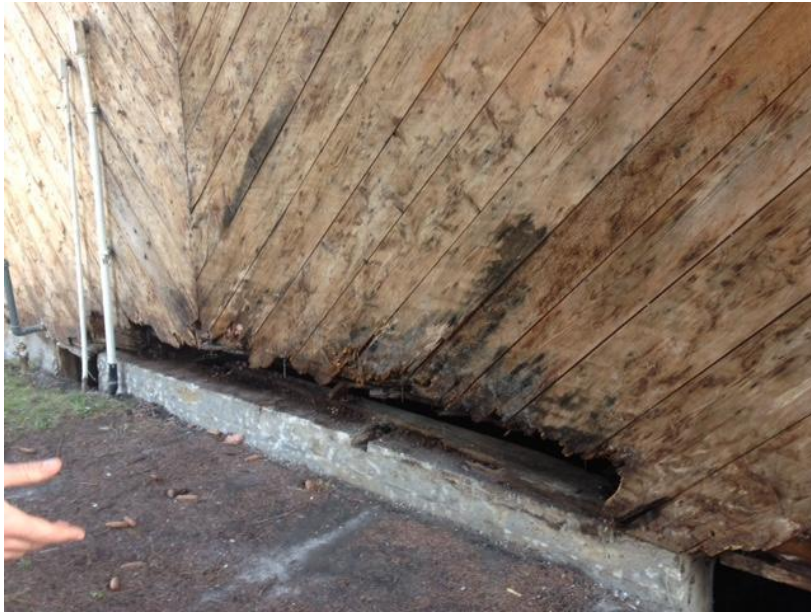
North wall

- RFP process
- Awarded to Bould Construction
- Plan was to remove exterior stucco, abate asbestos, re-side building, replace windows and doors
- Removal of siding (along with asbestos abatement) completed
- Unforeseen problems with wood rot on all walls, most prominently on North, East, and West walls
